# Walk Around

## Focke-Wulf Fw 190A/F

Walk Around Number 22  
squadron/signal publications

By Malcolm Laing and E. Brown Ryle

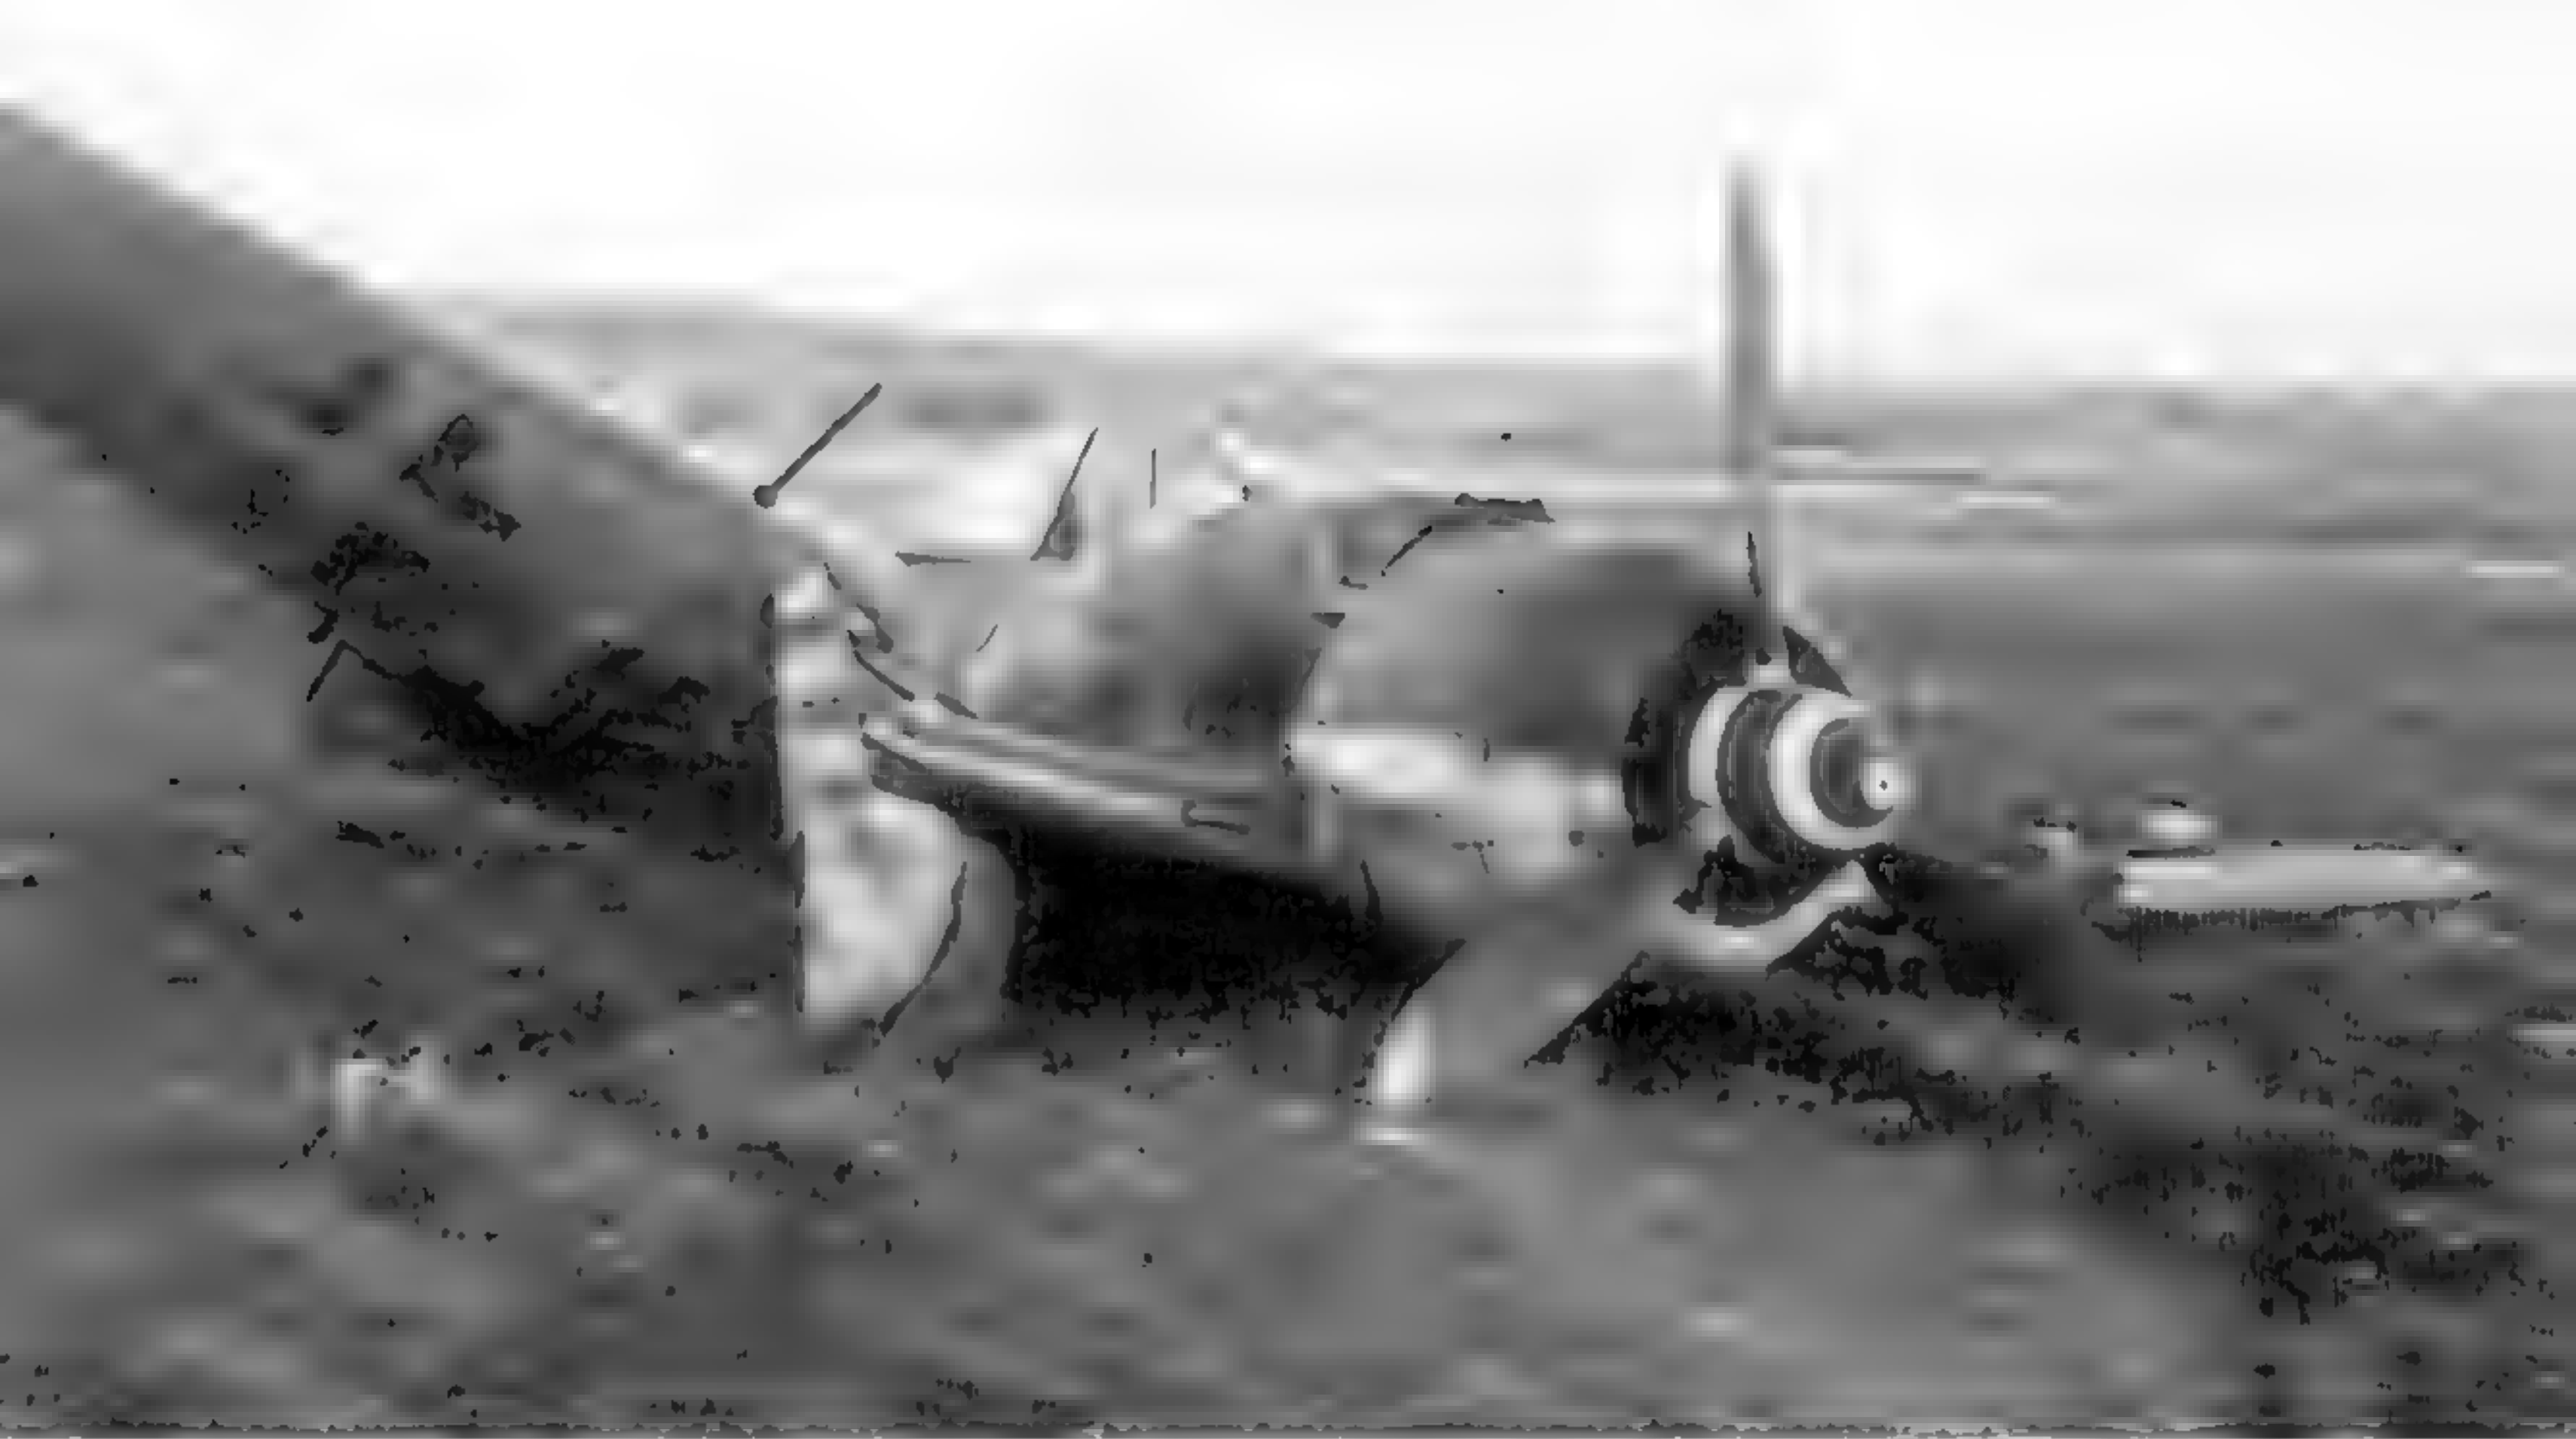
This Fw 190A-8 (W.Nr. 171189) was assigned to (Stab) II/SG 2 when *Major* Karl Kennel crash-landed it at Kitzingen, Germany on 8 May 1945 – the day World War II ended in Europe. Although equipped with an outboard 20mm MG151 cannon, the bulged access panel beneath the wing is associated with 30mm weapons. A second ejection chute has been cut into the 30mm panel to allow ejection of the spent 20mm shells. This is another view of the same aircraft seen on page 75. (Crow)

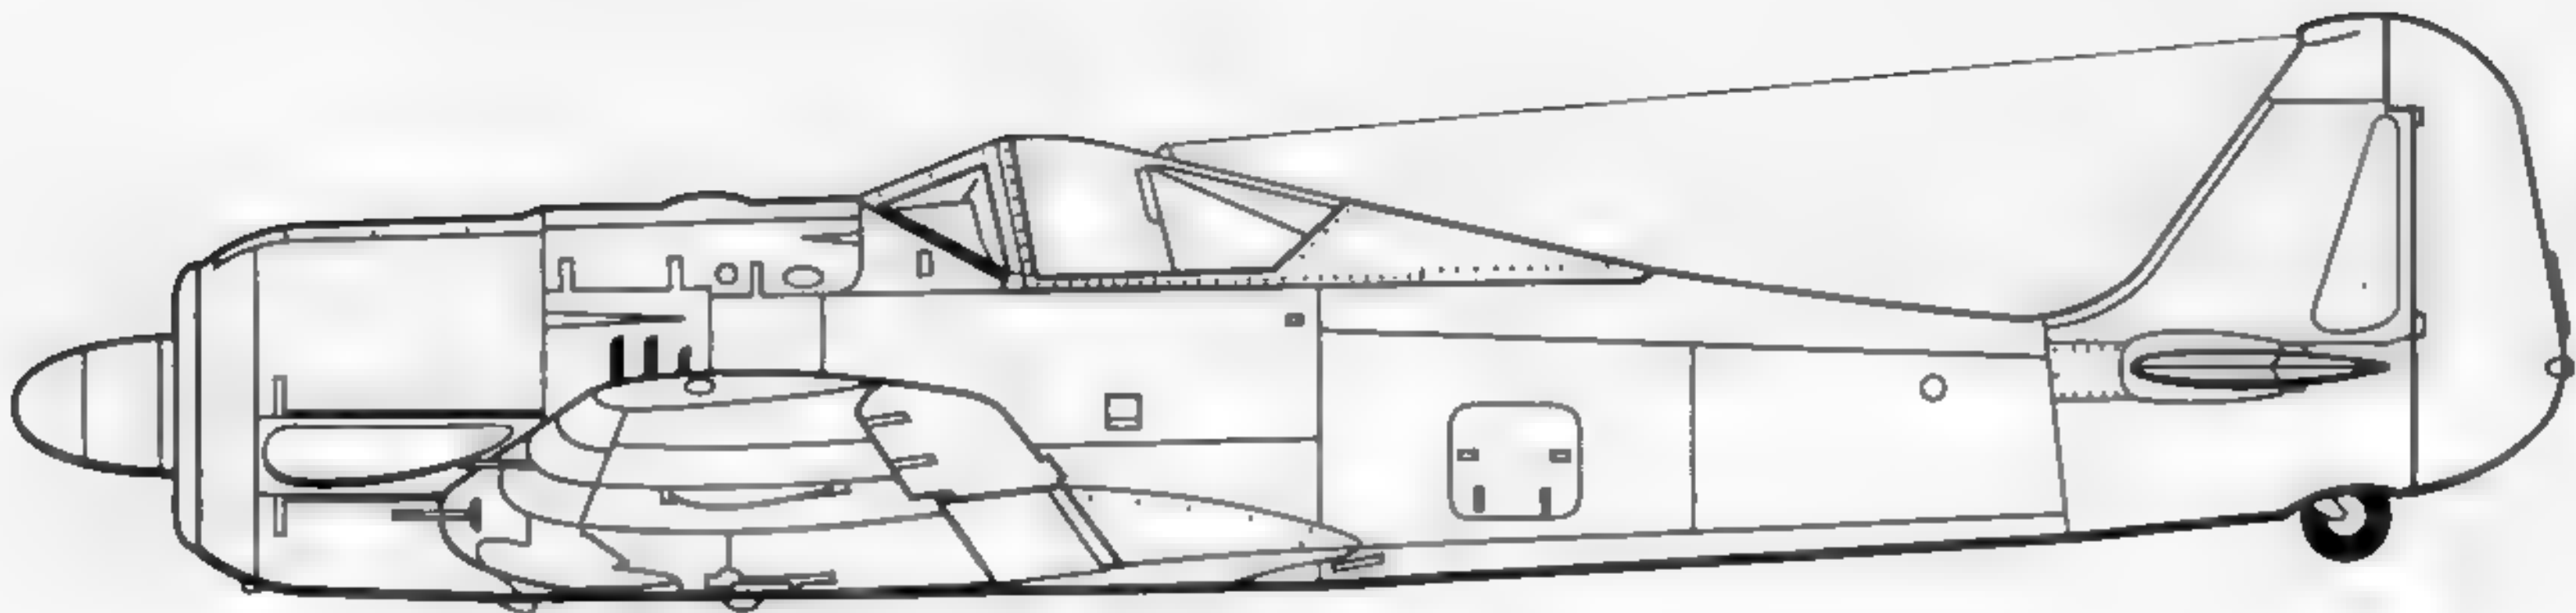
## Fw 190A-2

The Fw 190A-2 superseded the A-1 in production in August of 1941 and joined the earlier version in service the following Sept. The A-2 replaced the two wing-root-mounted "Bismarck" machine guns with 2x Ju. MG 16's gunns. The newer version was powered by a 1000+ Bfme 101D engine in place of the 850hp BMW 801C. With A-2's incorporating engine cooling ports immediately behind the cooling

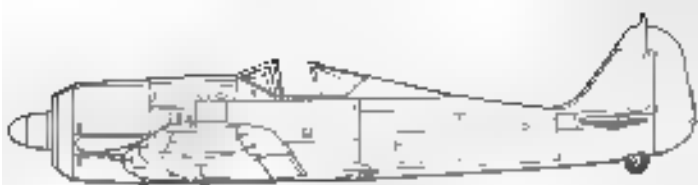
## **Fw 190A-3**

The A-3 standardized on the A-2's equipment, including the BMW 801D engine and the armament, although the two wing-mounted 20mm MG FF cannon were often removed to reduce weight and increase speed. An ETC 501 rack could be mounted on the fuselage underside to carry a 79.3 gallon (300 L) drop tank or a 551.1 lb (250 kg) or 1102.3 lb (500 kg) bomb. The Fw 190A-3 entered squadron service by the spring of 1942, serving alongside the A-2s and allowing withdrawal of the A-1s from frontline use.

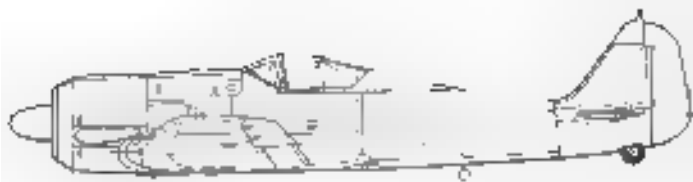
## Fw 190A-4

The A-4 retained the A-1's basic structure, however the newer version's FuG 16 radio resulted in the addition of a vertical stabilizer fin on top of the A-4's vertical stabilizer. A variety of factory and field conversions allowed the Fw 190A-4 to become a multi-role aircraft capable of ground-bomber, ground attack, photo reconnaissance and bomber destroyer roles. The first A-4s were delivered in June of 1942 and production continued until early 1943.

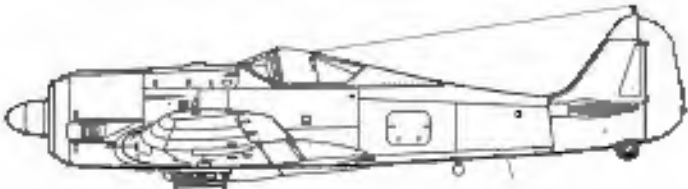
### Fw 190F-1

The Fw 190F series was developed for the close support role, replacing the obsolete Junkers Ju 87 Stuka dive bomber. The Fw 190F-1 was derived from the Fw 190A-6/U4 Jabo (Jagdbomber, Fighter-Bomber) conversion, in which the outboard wing 30mm cannons were deleted. Gun armament on this and subsequent Fw 190Fs was reduced to a pair of fuselage mounted 7.92mm (90) 17 machine guns and two wing-root mounted 20mm MG 151 cannons. An ETC 501 ventral bomb rack was installed to carry a single 551.1 lb (250 kg) or 1102.2 lb (500 kg) bomb, or four 110.2 lb (50 kg) bombs. Internal armor was added to the engine cowling, fuselage fuel tanks, and cockpit for protection against enemy fire. Approximately 20 Fw 190F-1s were built through the middle of 1943, and the majority of them served on the Eastern Front.

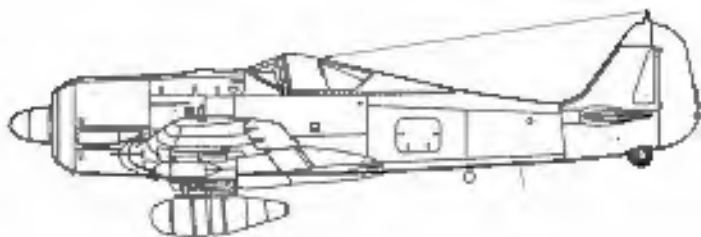
### **Fw 189F-2**

The Fw 189F-2 was a derivative of the Fw 189A-6A2 heavy conversion model, which retained the A-5's six-inch (152.5 mm) long fuselage extension over the Fw 189A-4. Internal and external armament remained the same as for the Fw 189F-1, and the internal armor protection was also retained. Many F-2s were built with side-cowl air intakes equipped with tropical filters to keep sand and dust out of the engine. Total Fw 189F-2 production came to 275 airplanes. Although most of these aircraft were assigned to the Eastern Front, several were deployed to the Mediterranean theater.

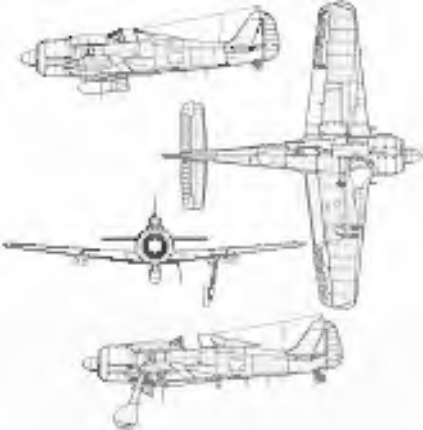
### Fw 190F-3

The Fw 190A-8/U17 factory conversion became the basis of the Fw 190F-3 ground attack aircraft. This aircraft added four ETC 50 bomb racks under the outboard wings – two racks per wing – to each carry a 50 kg bomb. The remaining armament and armor protection was retained from the Fw 190F-2. Tropical cooling filters were fitted to many F-3s and provision was made for installing a gun camera in the port wing leading edge. Around 270 Fw 190F-3s, the majority of which saw service on the Eastern Front. Production of the Fw 190F-4, F-5, and F-7 was cancelled in favor of the Fw 190G long-range fighter-bomber; however, Fw 190F series production ceased with the Fw 190F-8 in 1944.
